NIST NCSTAR 1-5A

Federal Building and Fire Safety Investigation of the World Trade Center Disaster

Visual Evidence, Damage Estimates, And Timeline Analysis

(Chapter 9 - Appendix C)

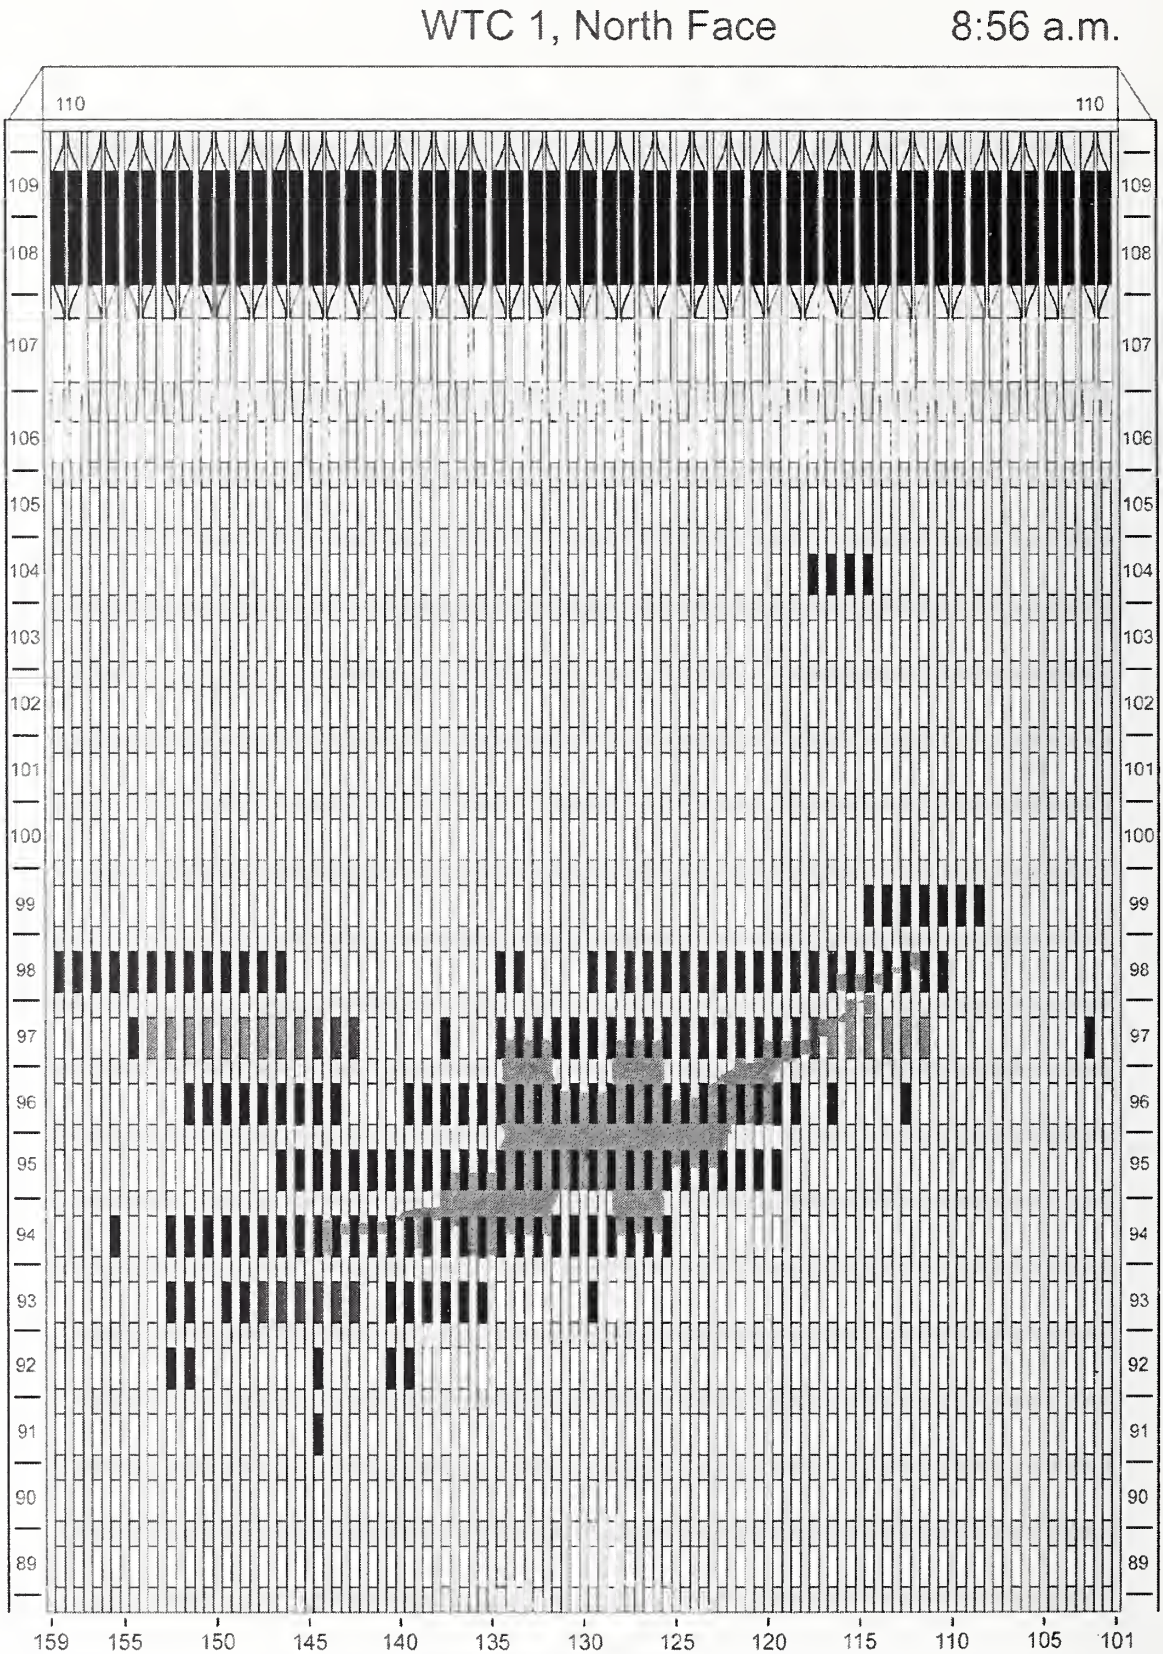
Figure C-11. Diagram of the north face of WTC 1 for floors 89 to 110 at 8:56 a.m. showing the condition of windows and locations of lines.

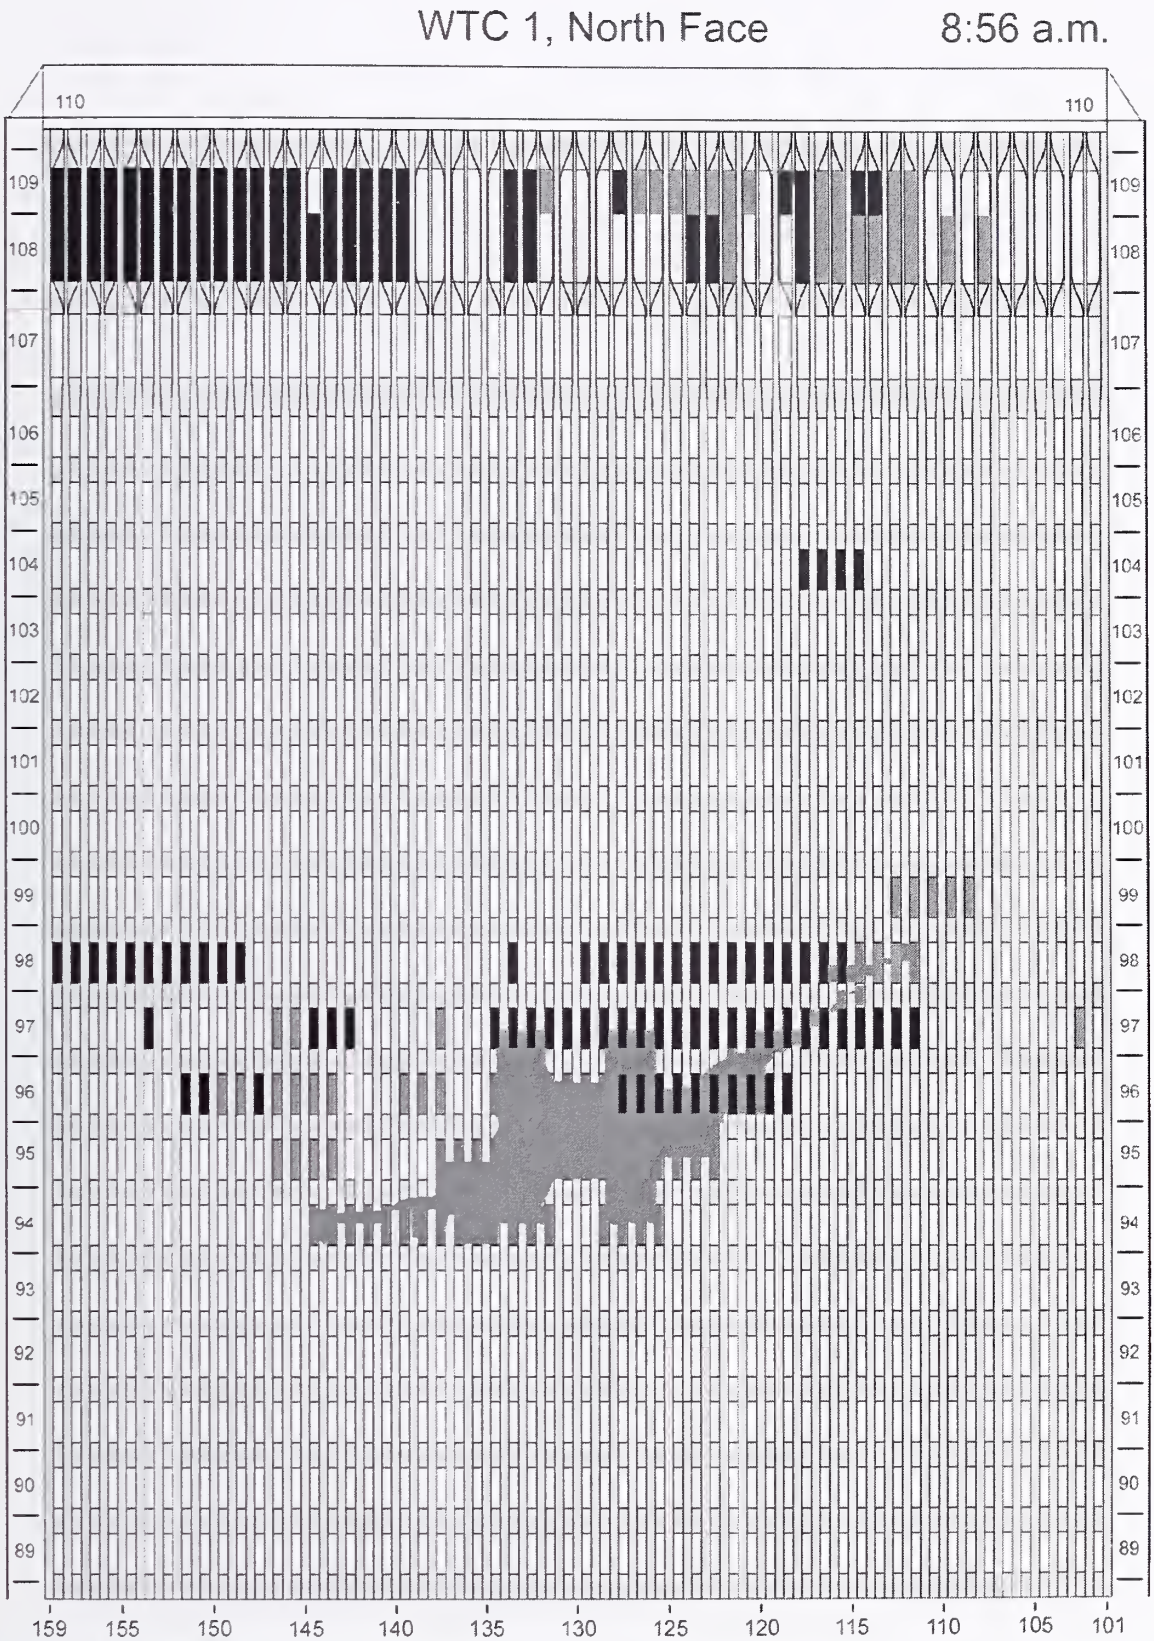
Figure C-12. Diagram of the north face of WTC 1 for floors 89 to 110 at 8:56 a.m. showing windows where smoke was observed and those that were hidden from view.

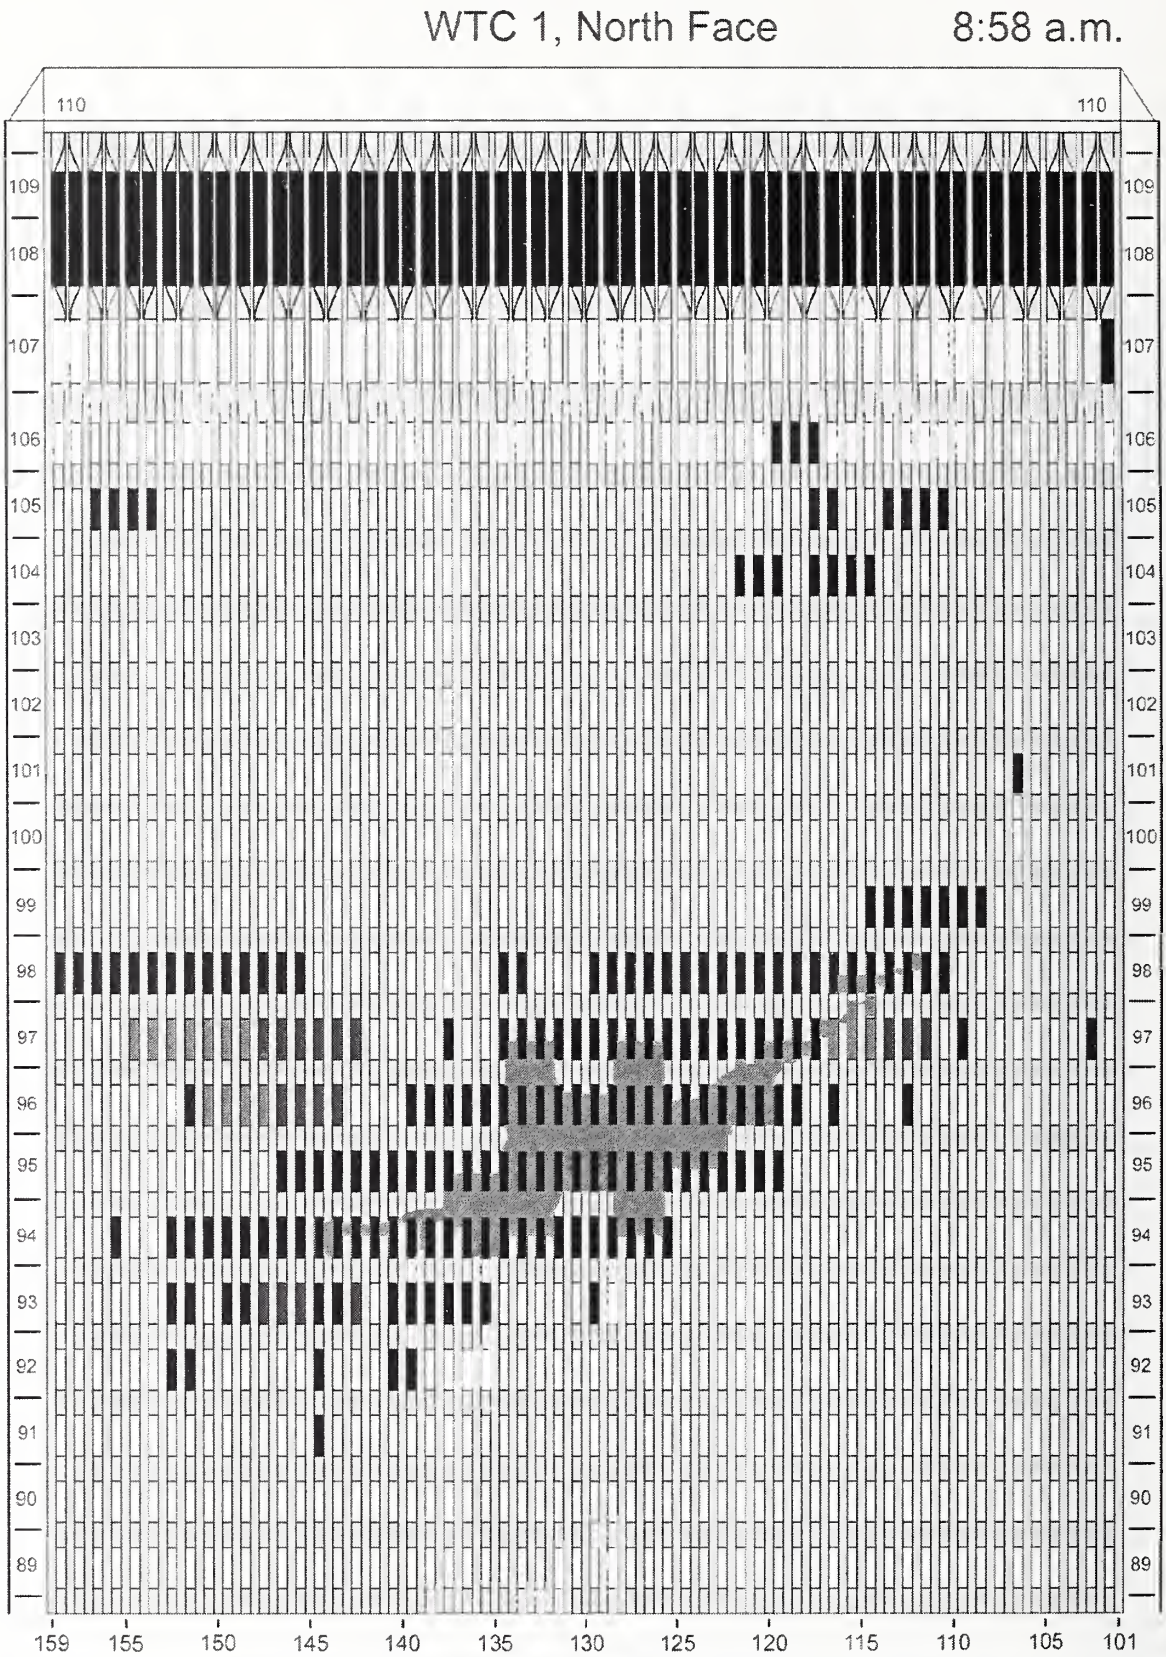
Figure C-13. Diagram of the north face of WTC 1 for floors 89 to 110 at 8:58 a.m. showing the condition of windows and locations of fires.

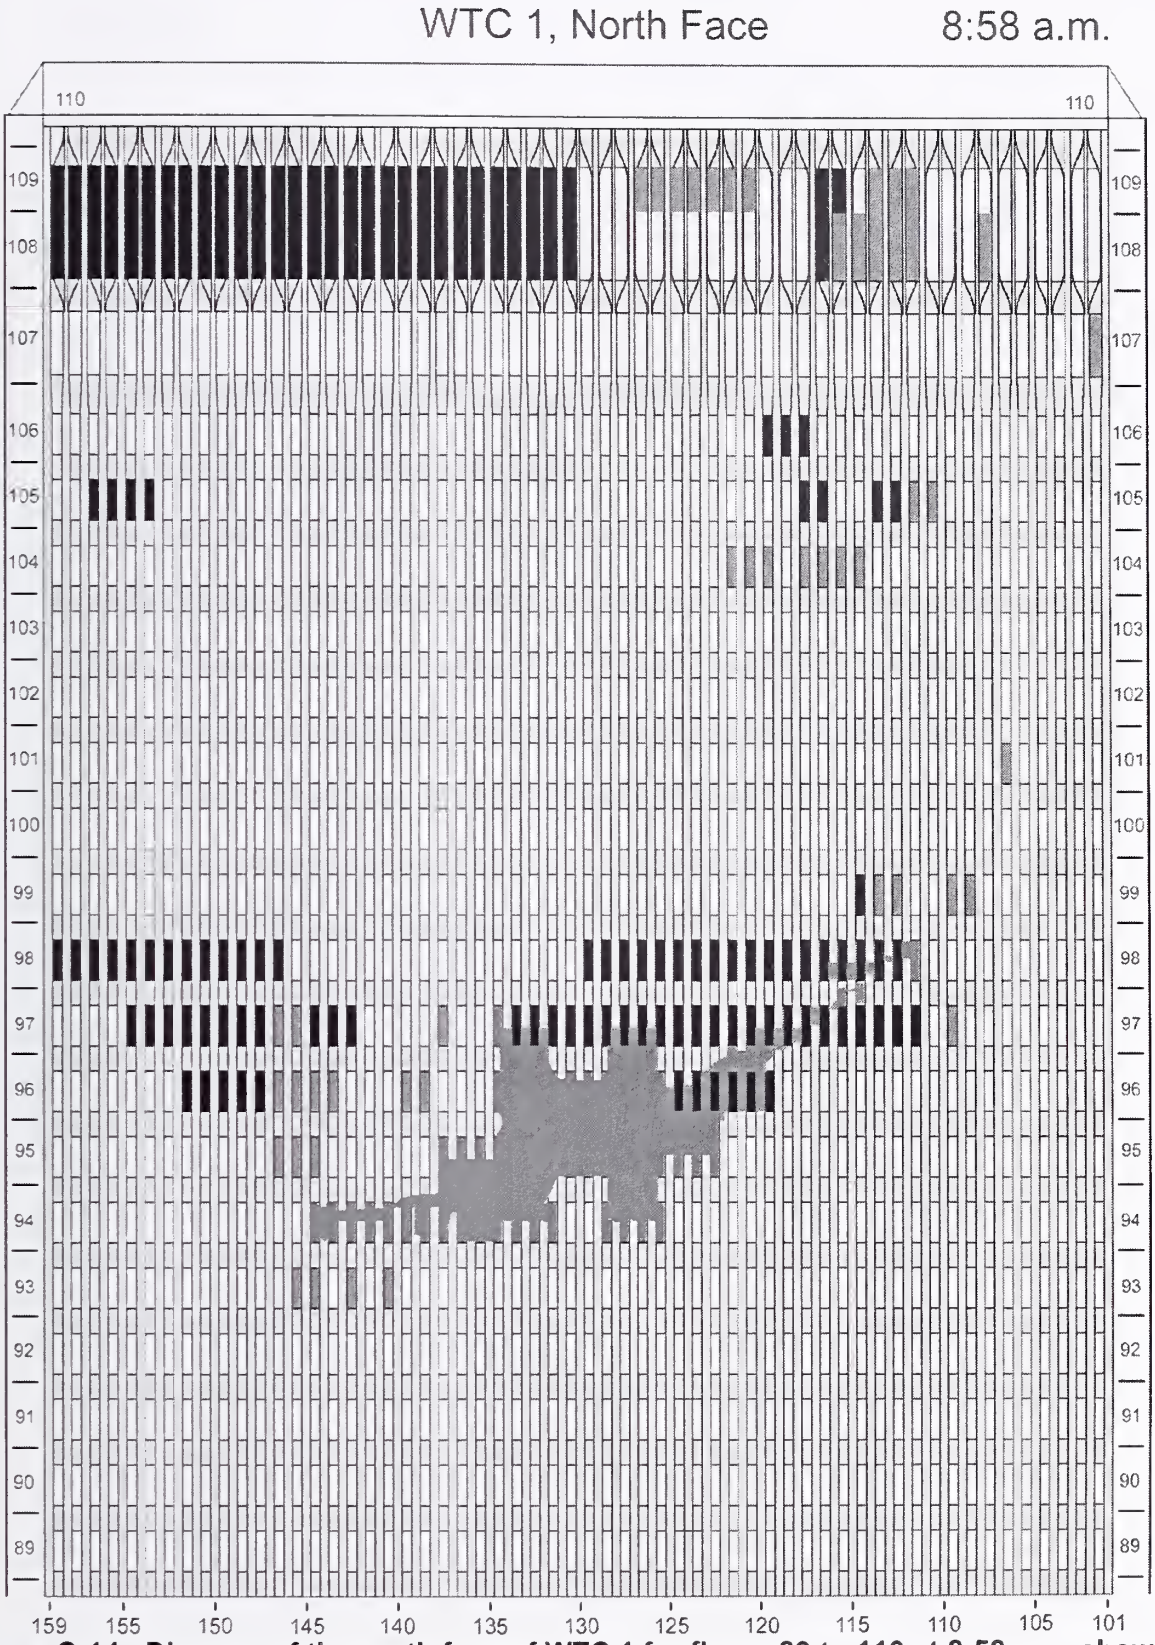
Figure C-14. Diagram of the north face of WTC 1 for floors 89 to 110 at 8:58 a.m. showing windows where smoke was observed and those that were hidden from view.

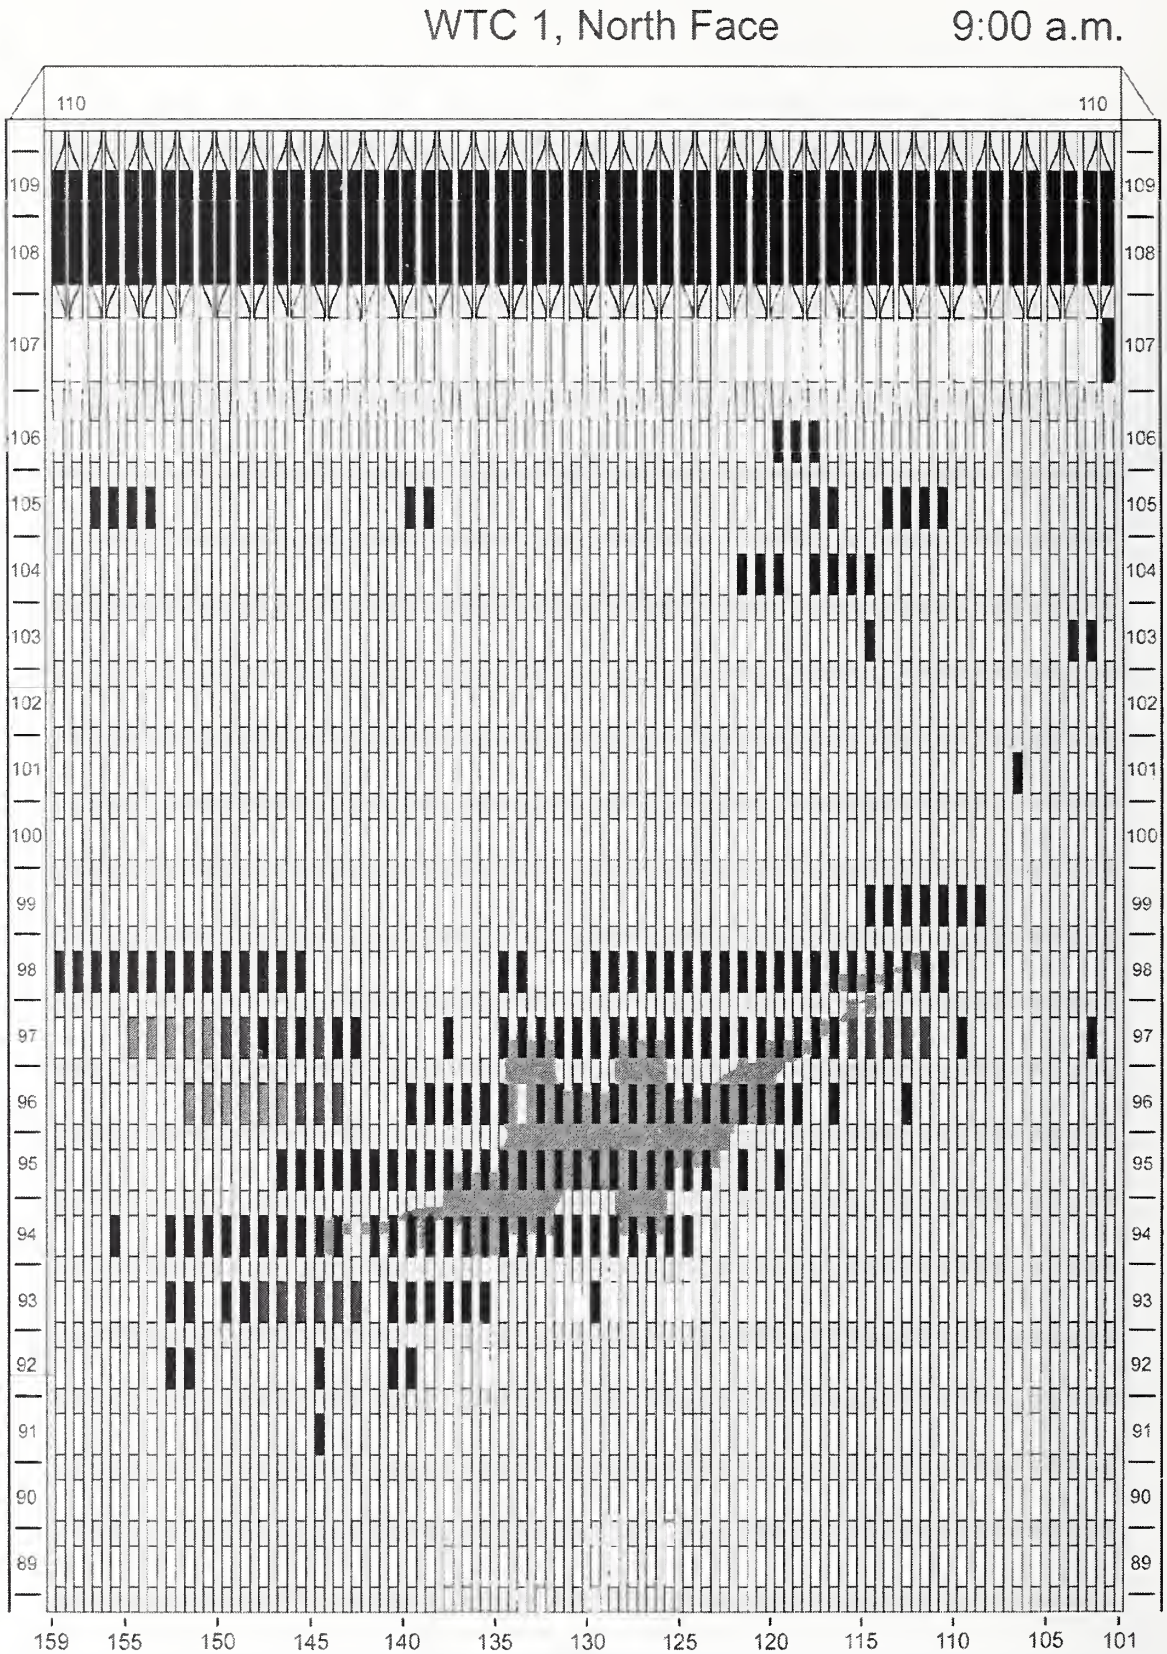
Figure C-15. Diagram of the north face of WTC 1 for floors 89 to 110 at 9:00 a.m. showing the condition of windows and locations of fires.

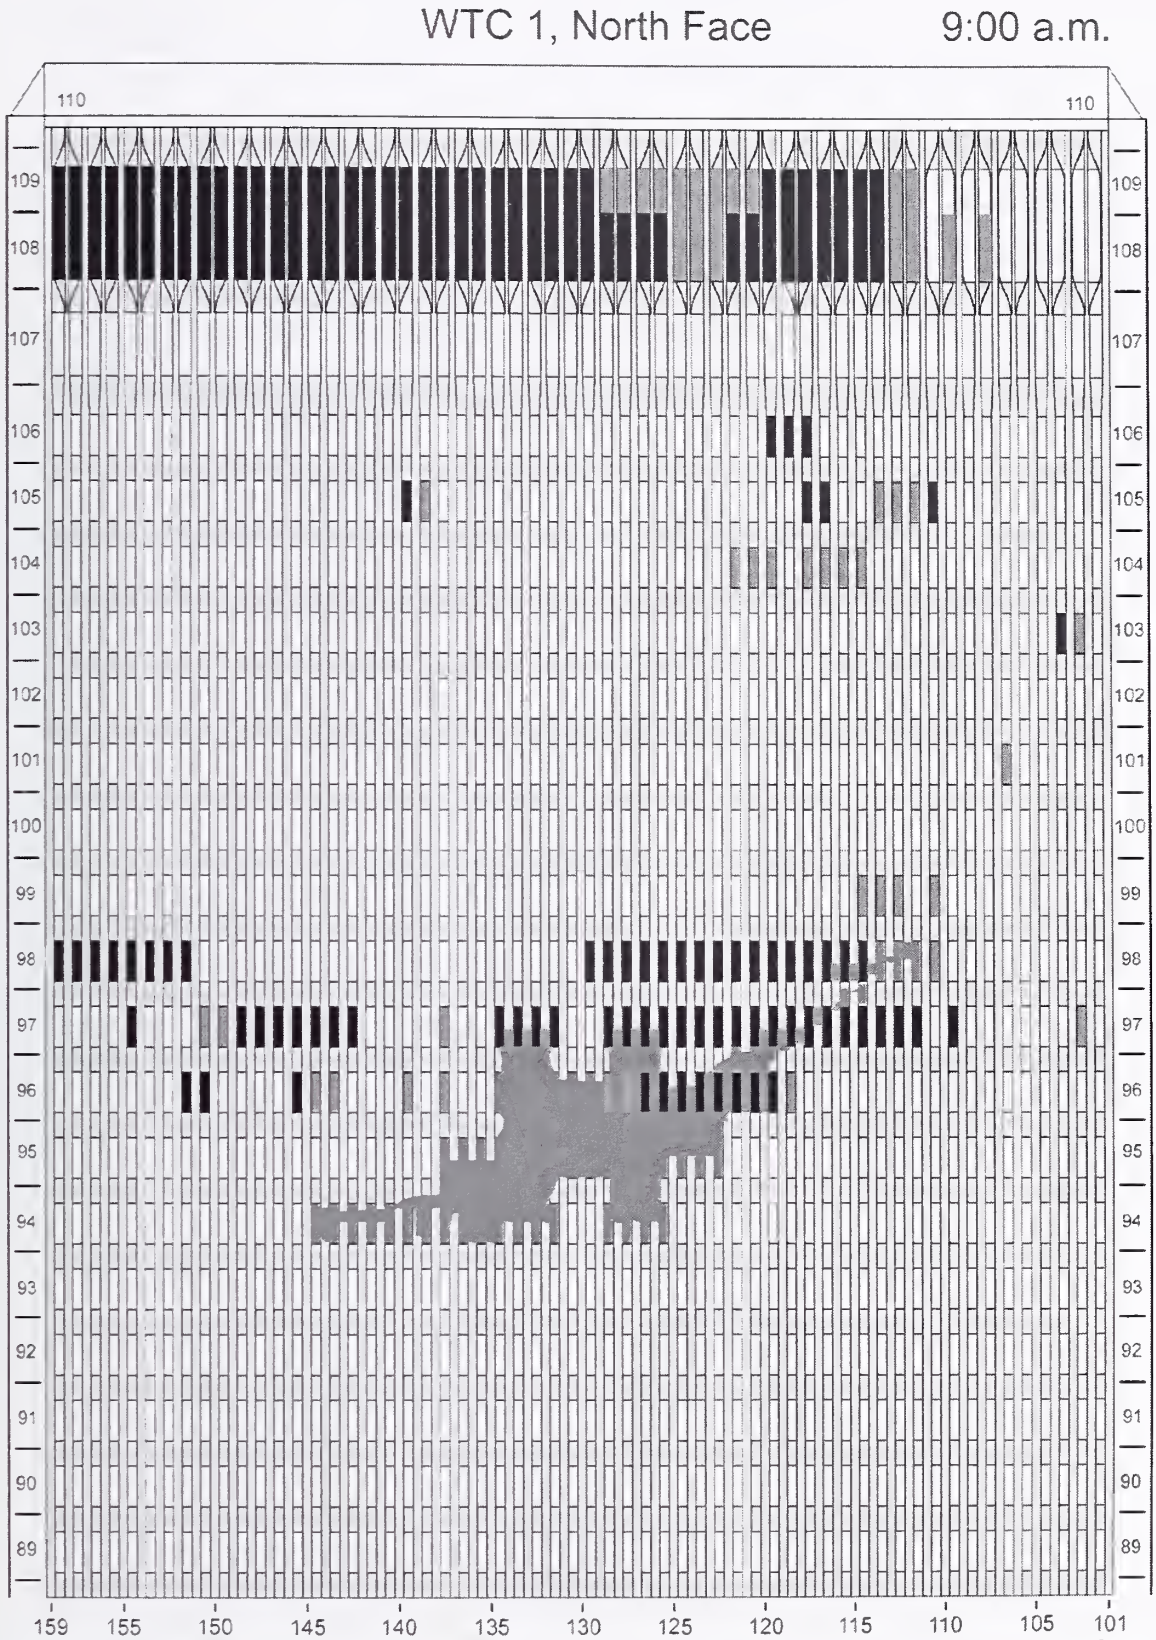
Figure C-16. Diagram of the north face of WTC 1 for floors 89 to 110 at 9:00 a.m. showing windows where smoke was observed and those that were hidden from view.

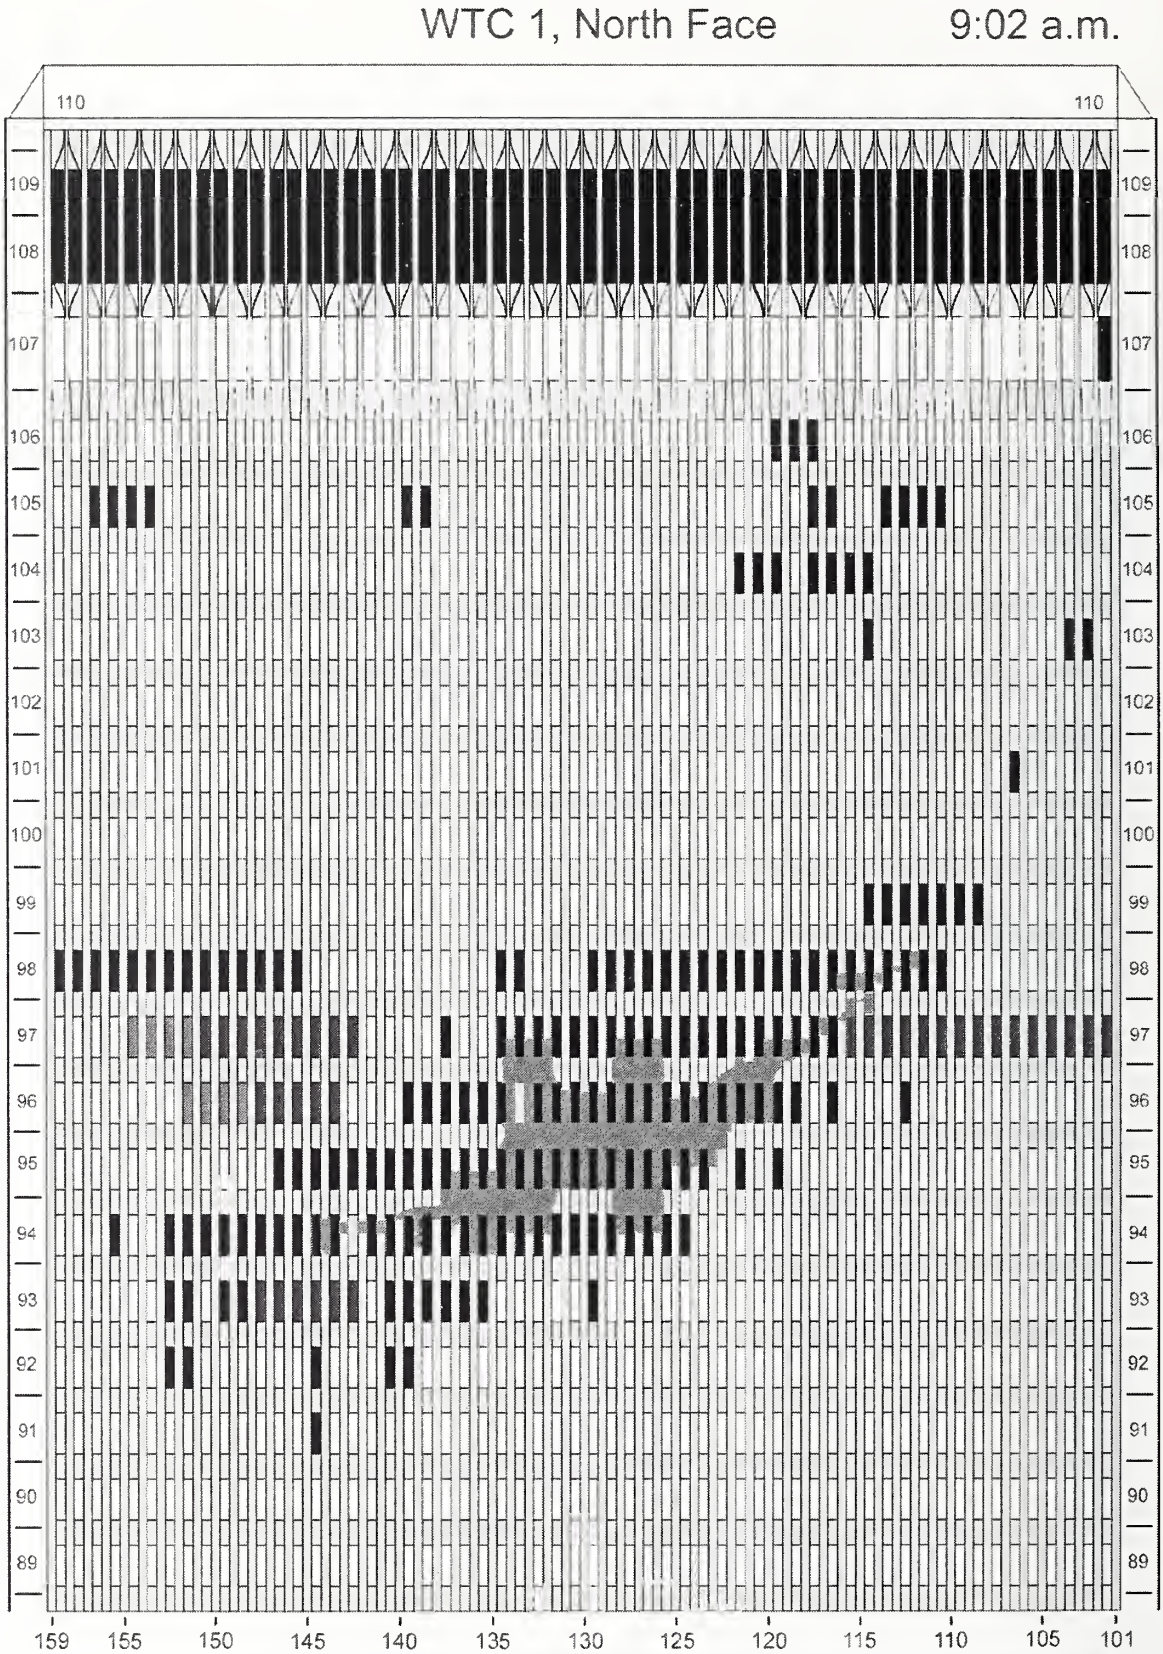
Figure C-17. Diagram of the north face of WTC 1 for floors 89 to 110 at 9:02 a.m. showing the condition of windows and locations of fires.

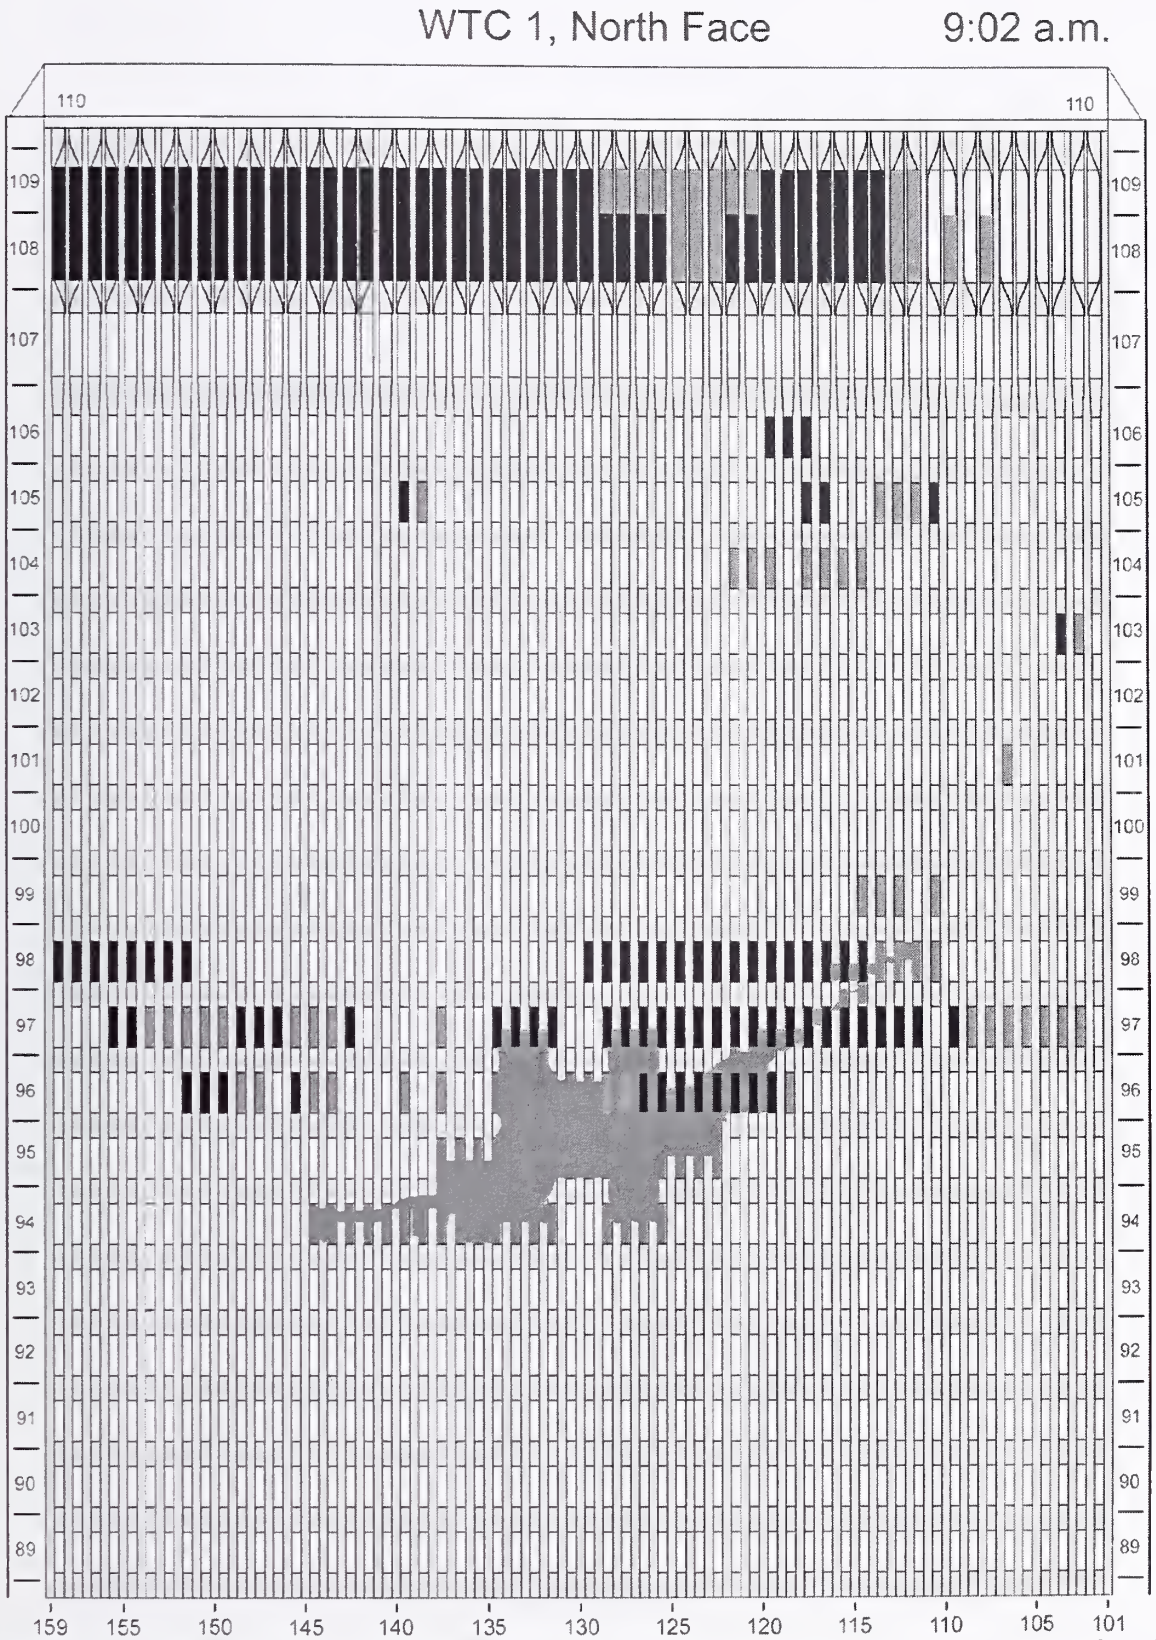
Figure C-18. Diagram of the north face of WTC 1 for floors 89 to 110 at 9:02 a.m. showing windows where smoke was observed and those that were hidden from view.

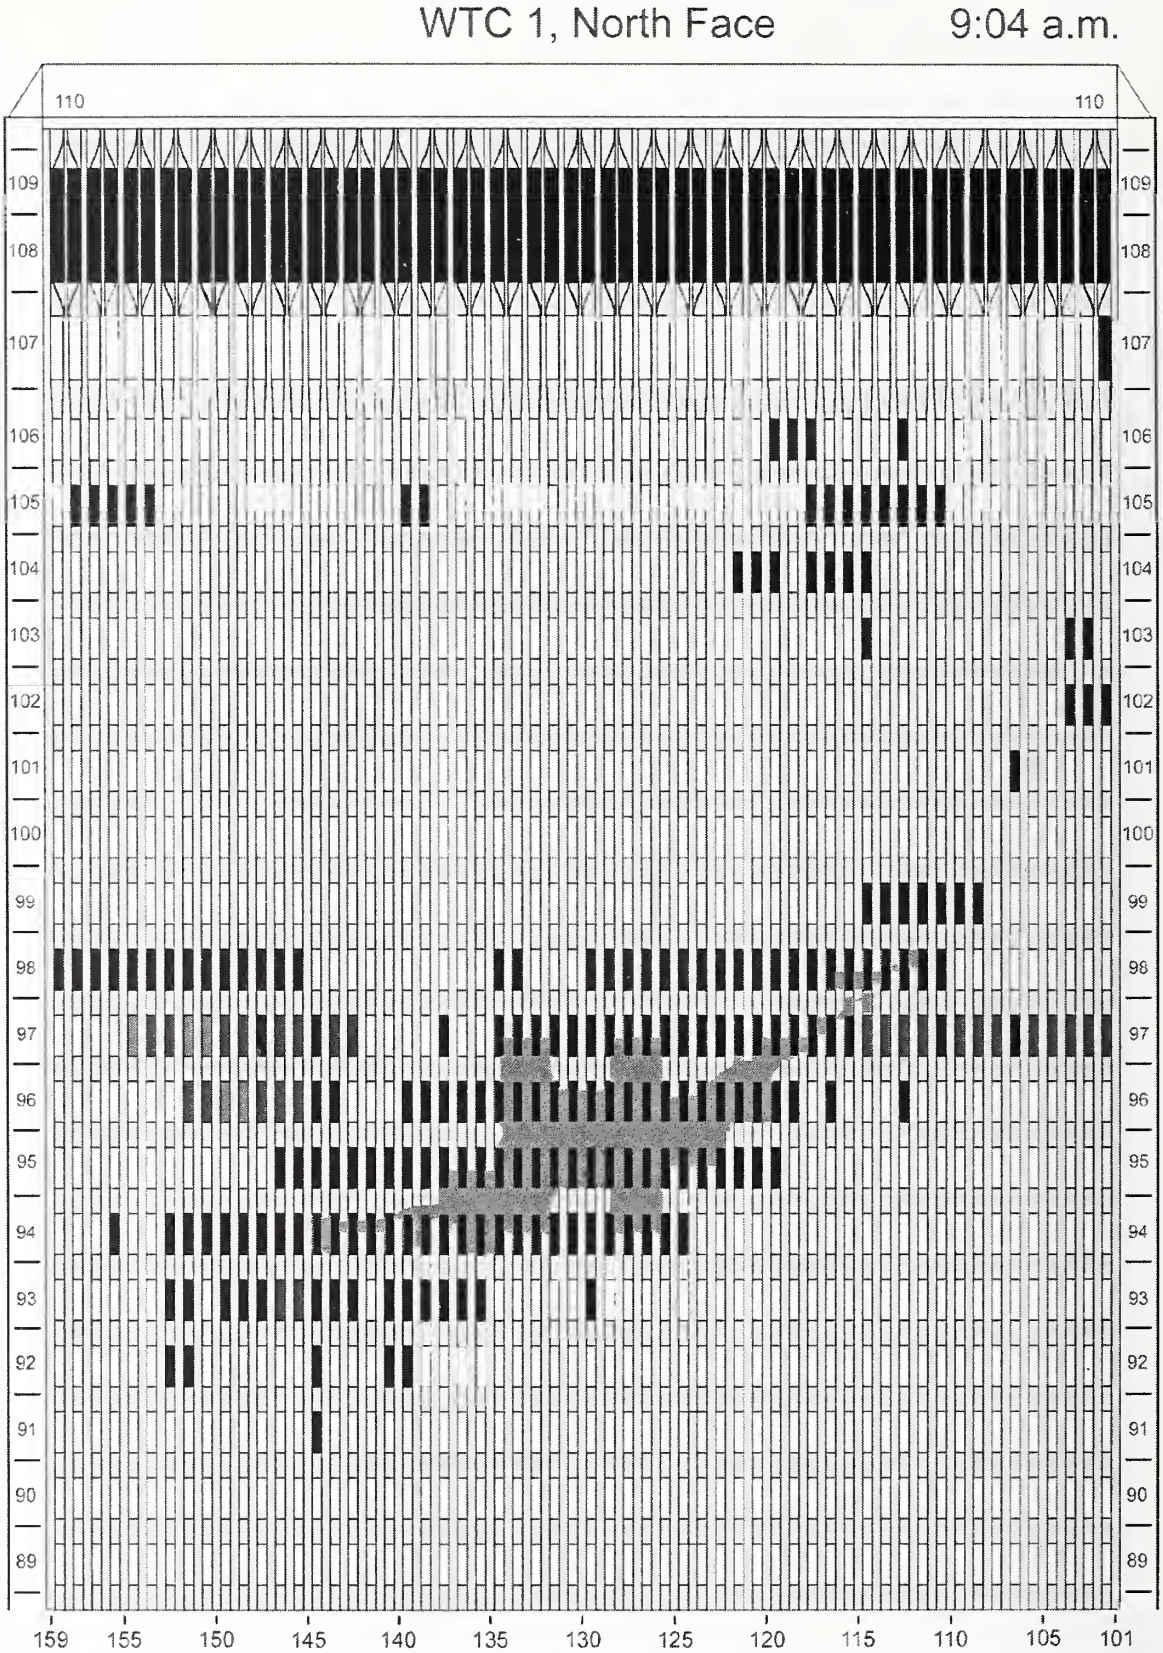
Figure C-19. Diagram of the north face of WTC 1 for floors 89 to 110 at 9:04 a.m. showing the condition of windows and locations of fires.

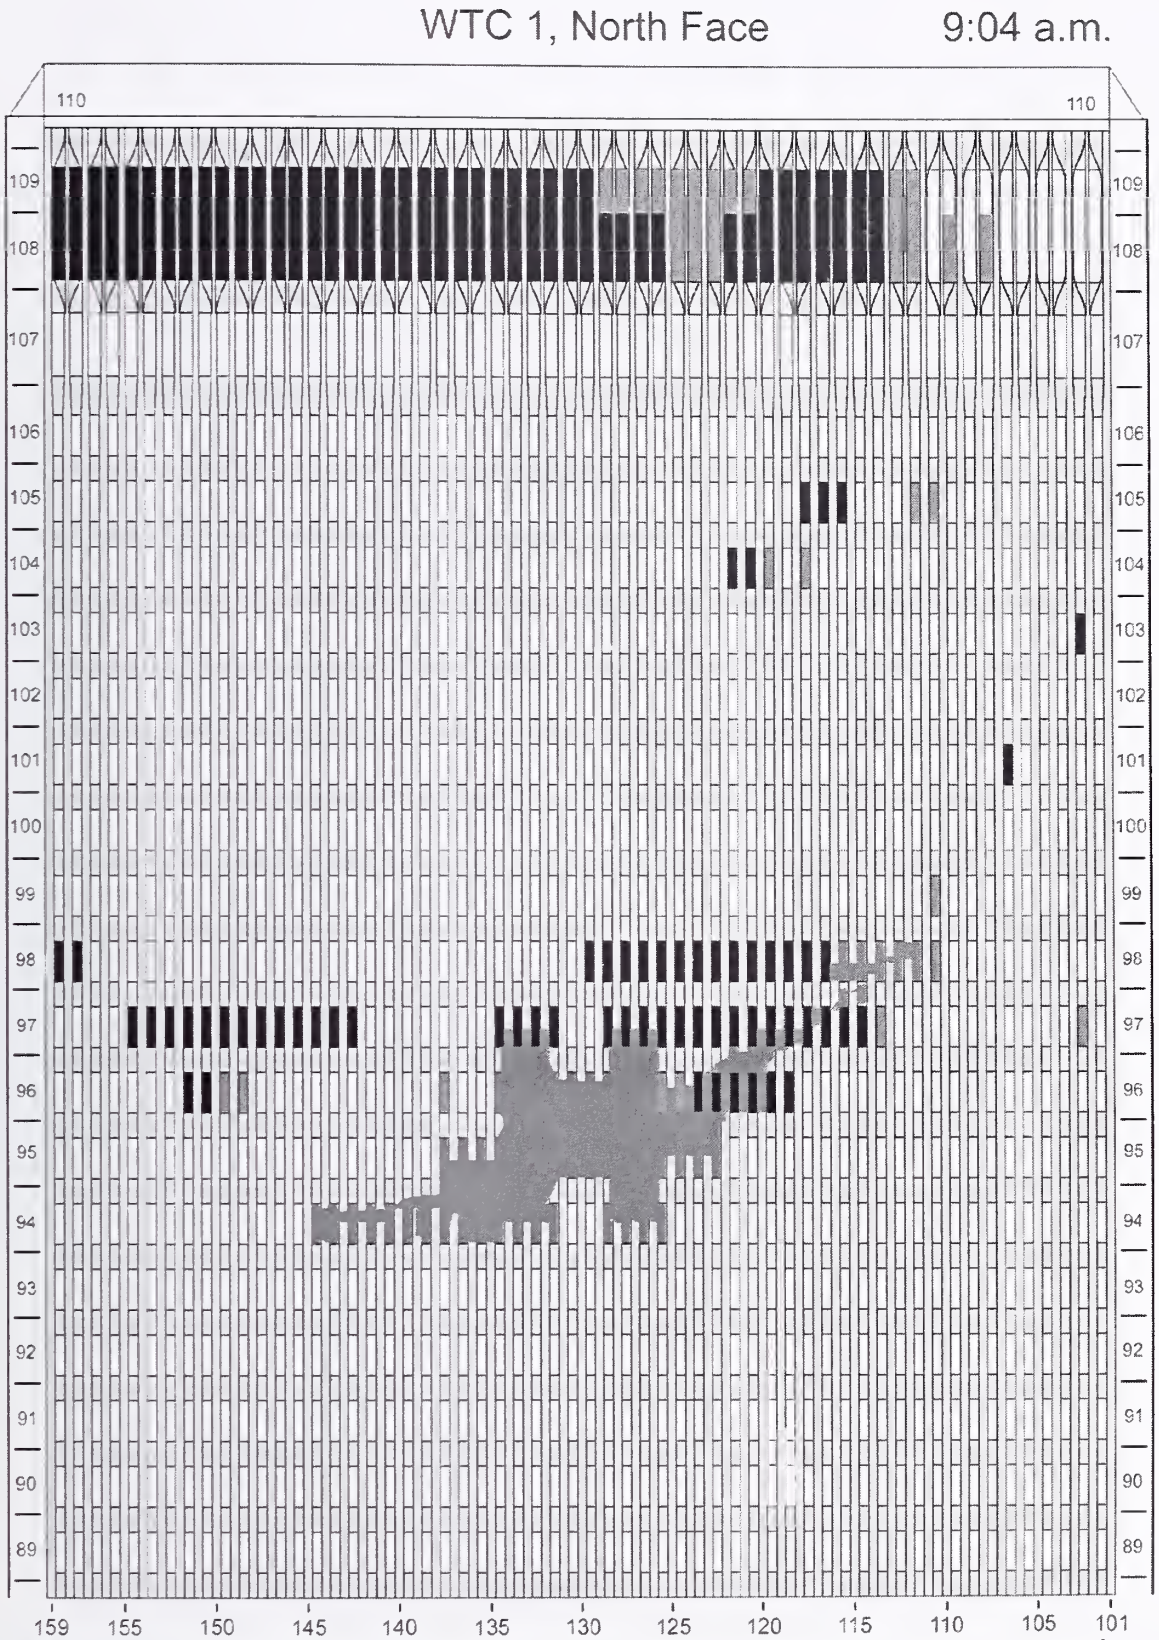
Figure C-20. Diagram of the north face of WTC 1 for floors 89 to 110 at 9:04 a.m. showing windows where smoke was observed and those that were hidden from view.

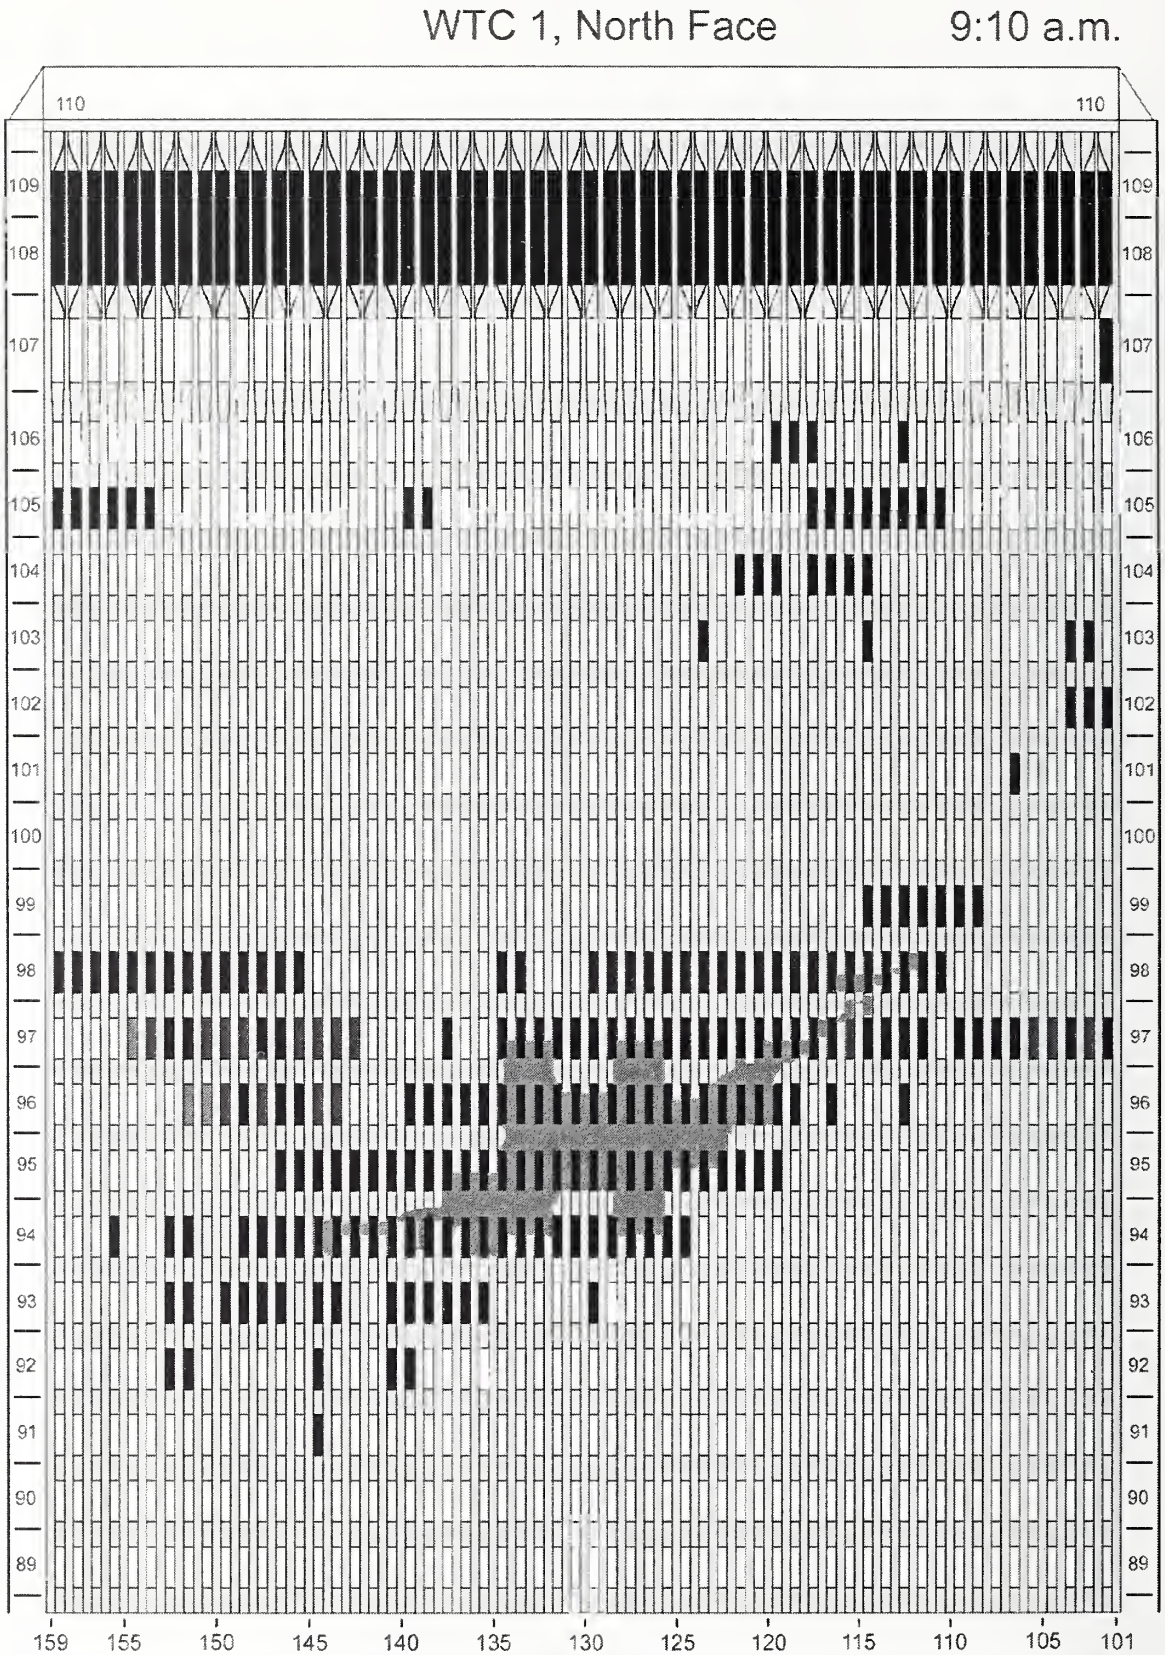
Figure C-21. Diagram of the north face of WTC 1 for floors 89 to 110 at 9:10 a.m. showing the condition of windows and locations of fires.
